Re: Notice of Violation
Compliance Evaluation Inspection
ILD 005 070 495

Photographs for EMCO Chemical Distributor CEI 7/23/15

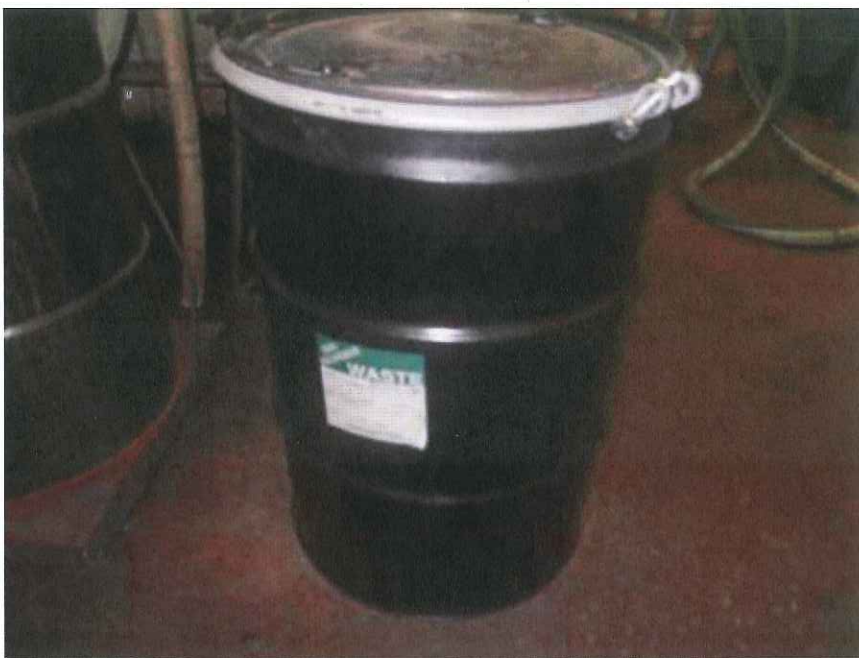
Non-hazardous waste storage 55-gallon container.

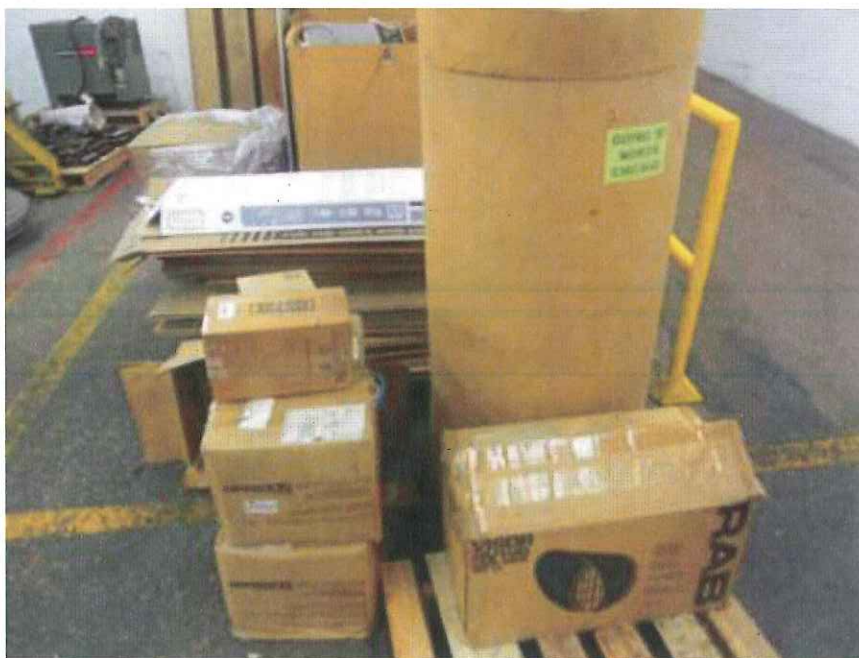
Disk Number 1
Photo Number 2
Photo Filename DSCN0857.JPG
Date/Time 7/23/2015
11:28:00 AM
Photographer Jamie Paulin

SA01 Building. Universal waste and e-waste storage area.

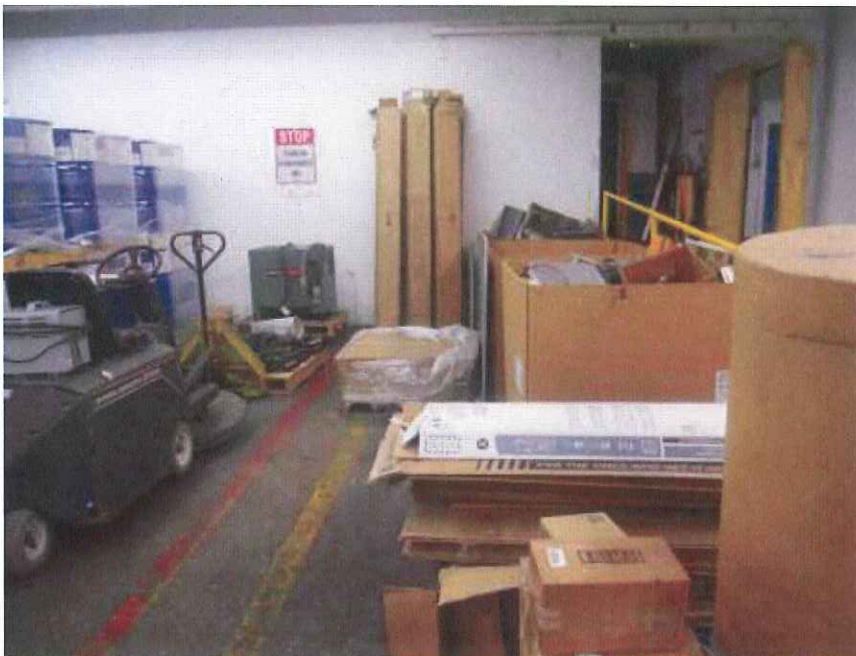
SA01 Building. Universal waste and e-waste storage area.

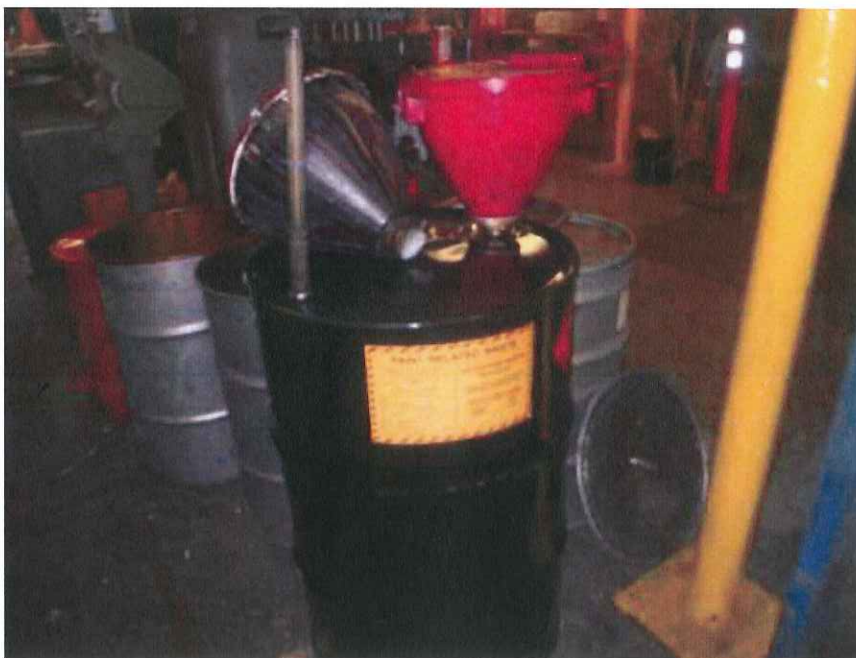
Disk Number 1
Photo Number 4
Photo Filename DSCN0859.JPG
Date/Time 7/23/2015
11:31:00 AM
Photographer Jamie Paulin

Maintenance area. Satellite Accumulation Area (SAA). Part-related waste.

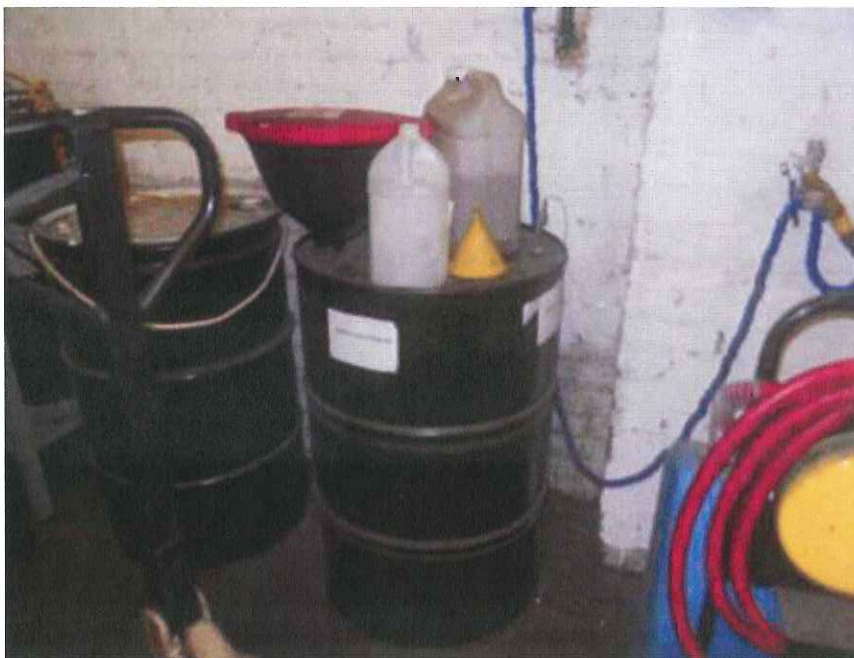
Maintenance Area. Non hazardous waste anti-freeze.

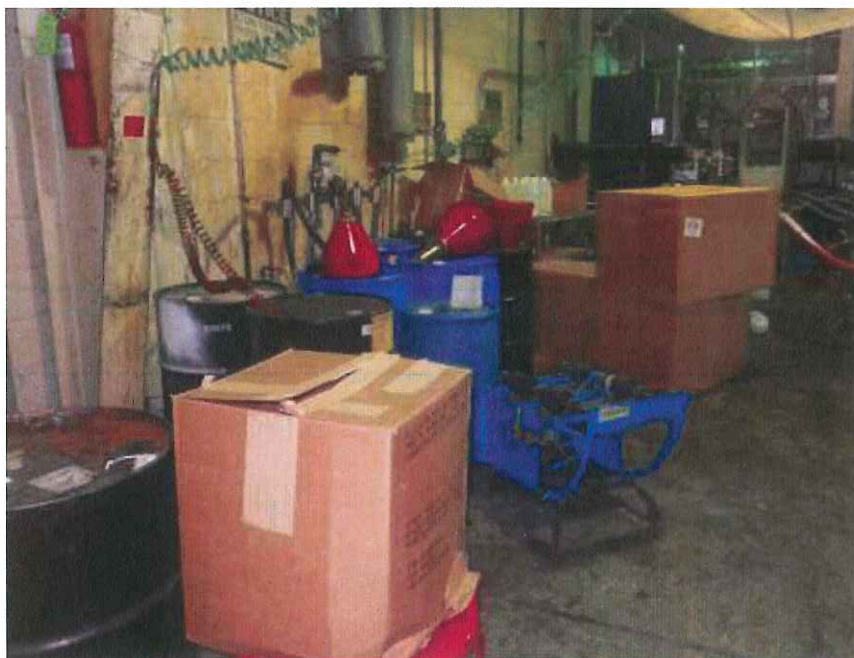
Disk Number 1
Photo Number 6
Photo Filename DSCN0861.JPG
Date/Time 7/23/2015
11:35:00 AM
Photographer Jamie Paulin

Mr. Schlie showed me the Production Fill Room. The Production Fill Room was located a step or two lower from the main floor. Facing the inside of the room, six 55-gallon containers of hazardous waste were being stored next to each other on the left side of the room. Mr. Schlie stated that this area was a satellite accumulation area and not a 90-day storage area. In the middle of the room, three 55-gallon containers of hazardous waste were being stored next to each other also described by Mr. Schlie as SAA containers. On the right side of the room, one 55-gallon container of hazardous waste was being stored as an SAA container. *See*, photographs 6 through 8.

Production Fill Room SAA containers. Six 55-gallon containers of hazardous waste were stored next to each other.

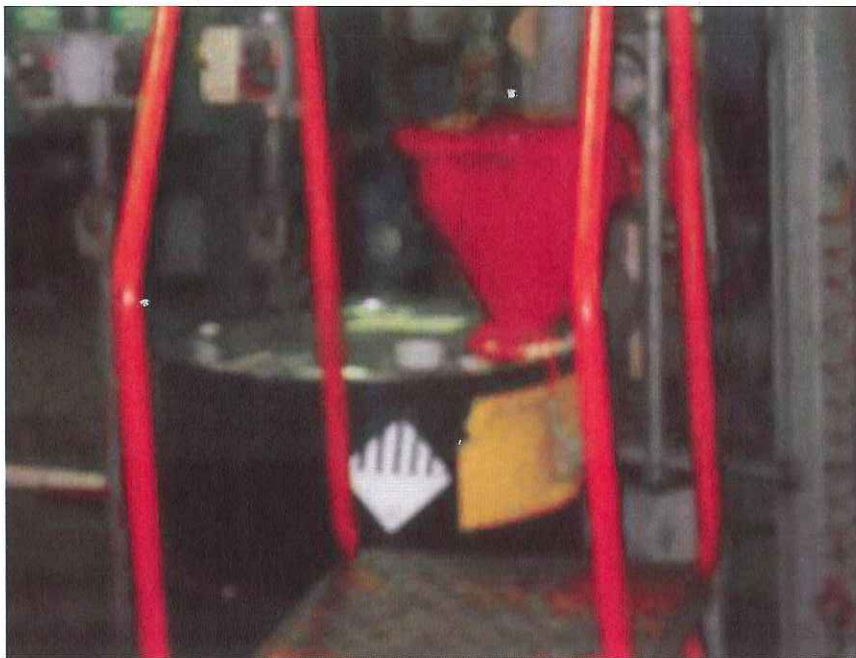
Production Fill Room. An SAA container of hazardous waste was being stored in this location.

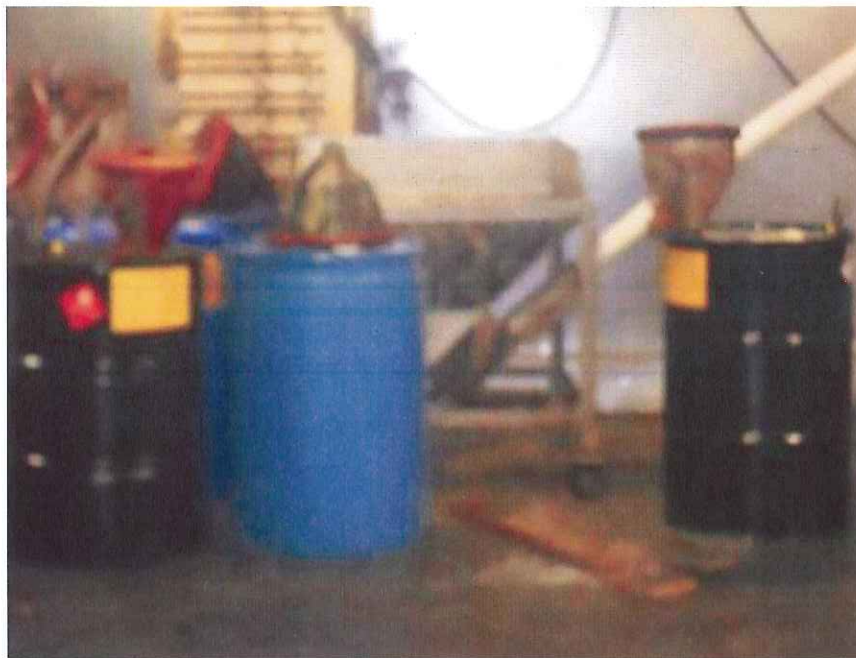
Disk Number 1
Photo Number 8
Photo Filename DSCN0863.JPG
Date/Time 7/23/2015
11:42:00 AM
Photographer Jamie Paulin

Production Fill Room. Three 55-gallon containers of hazardous waste were being stored near each other.

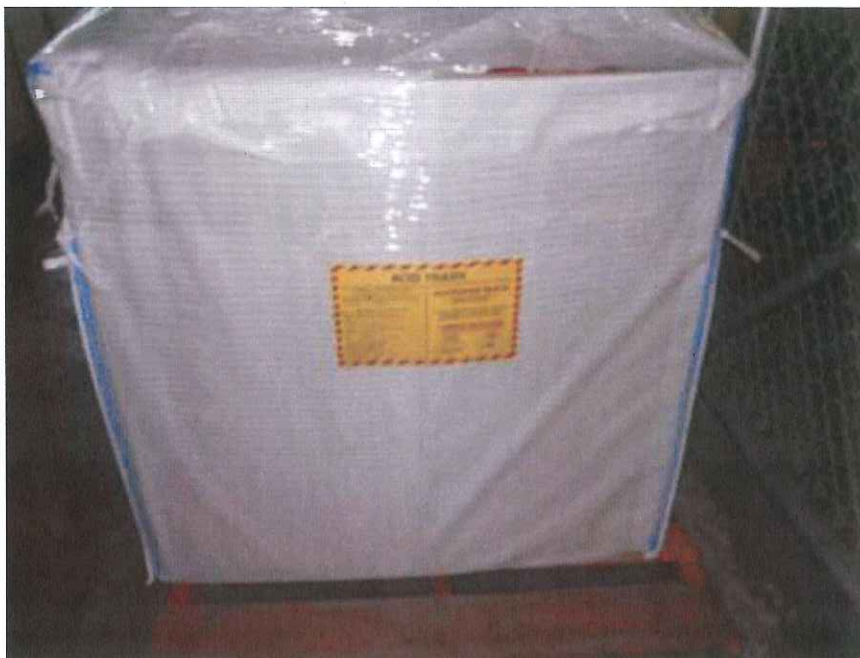
Laboratory. One tote of hazardous waste was being stored in this location. The date on the label was 1/6/15, over the 90 day storage time. No weekly inspections were being done in this area.

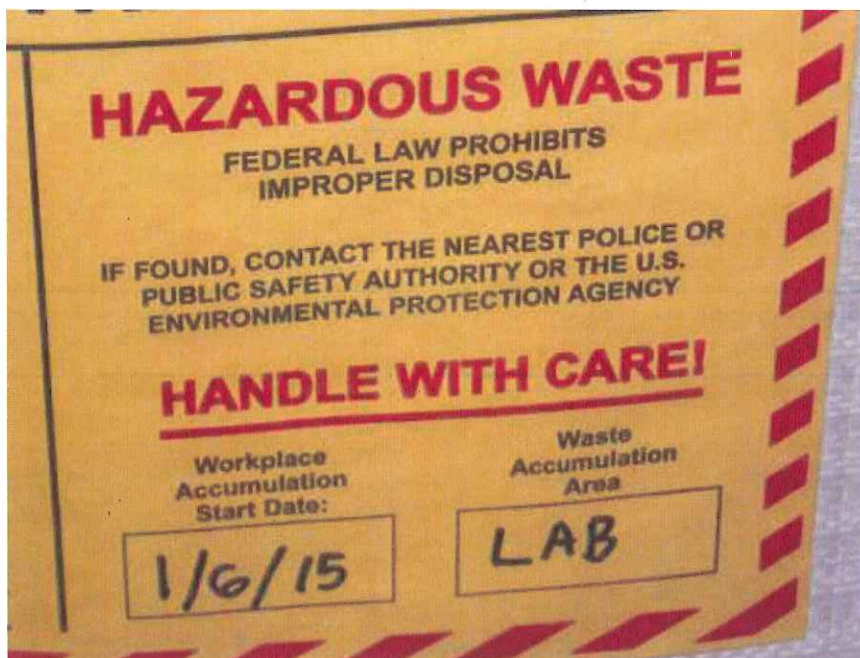
Disk Number 1
Photo Number 10
Photo Filename DSCN0865.JPG
Date/Time 7/23/2015
11:57:00 AM
Photographer Jamie Paulin

Laboratory. One tote of hazardous waste was being stored in this location. The date on the label was 1/6/15, over the 90 day storage time. No weekly inspections were being done in this area.

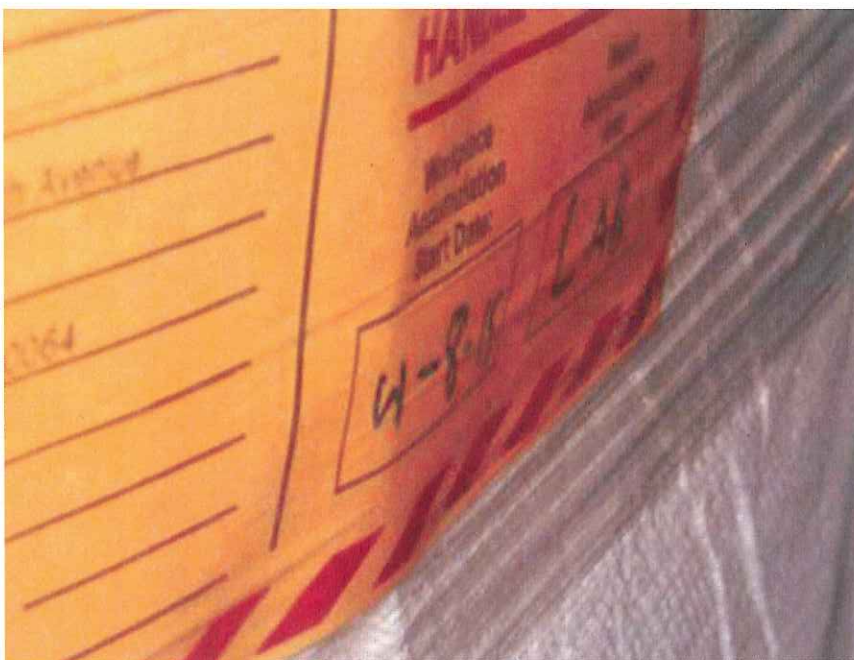
Laboratory. One tote of hazardous waste was being stored in this location. The date on the label was 4/8/15, over the 90 day storage time. No weekly inspections were being done in this area.

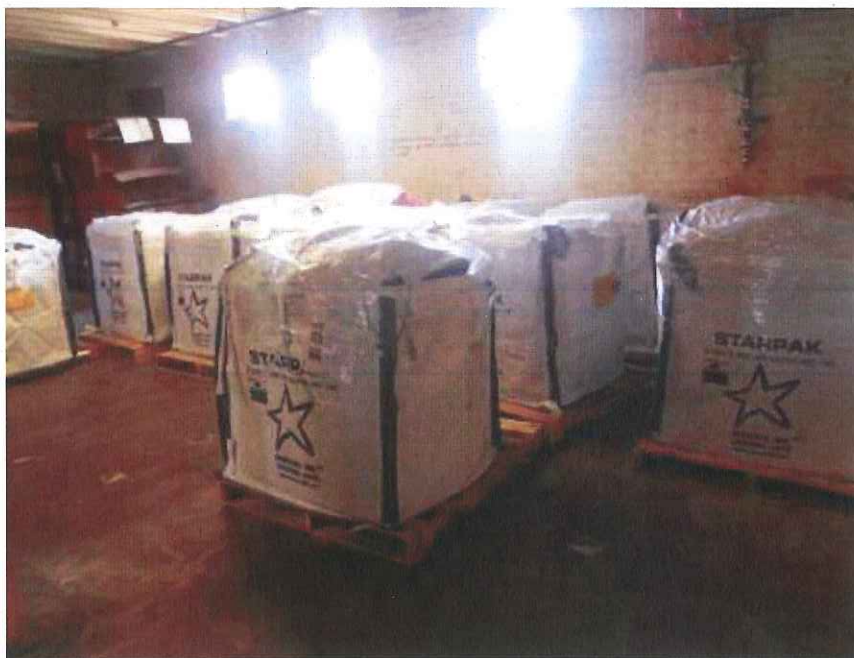
Disk Number 1
Photo Number 12
Photo Filename DSCN0867.JPG
Date/Time 7/23/2015
11:57:00 AM
Photographer Jamie Paulin

Laboratory. Fourteen totes of hazardous waste were being stored as SAA containers. No weekly inspection was being performed in this area.

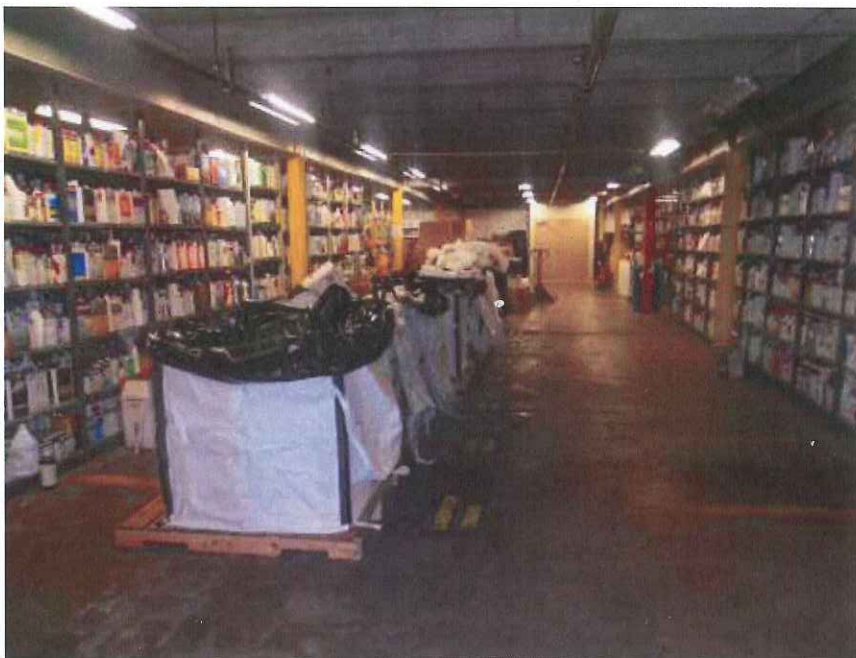
In the room adjacent to the tote storage, seven totes of hazardous waste were being stored open and without dates of accumulation or the words, "Hazardous Waste." The wastes were identified by words painted on the floor, such as flammable trash or caustic trash. Some of the totes were over-flowing with bags of hazardous waste and were not able to be closed. These wastes were generated at the lab as any type of contaminated lab waste. *See*, photographs 13 and 14.

Laboratory. Seven totes of hazardous waste were being stored in this location open and not labeled with the dates of accumulation or the words, "Hazardous Waste."

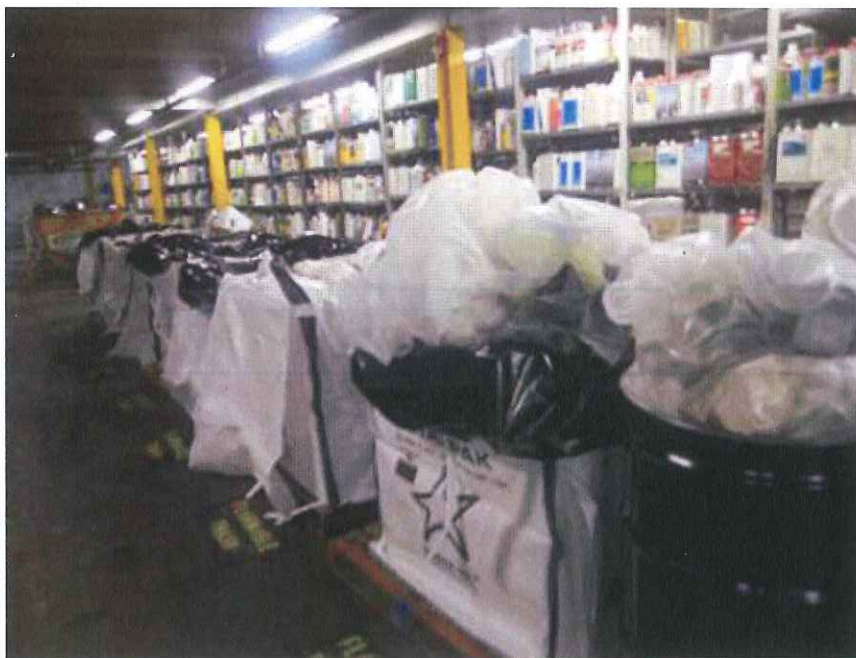
Disk Number 1
Photo Number 14
Photo Filename DSCN0869.JPG
Date/Time 7/23/2015
11:59:00 AM
Photographer Jamie Paulin

Laboratory. Seven totes of hazardous waste were being stored in this location open and not labeled with the dates of accumulation or the words, "Hazardous Waste." The waste was identified by words on the floor but not as hazardous waste.

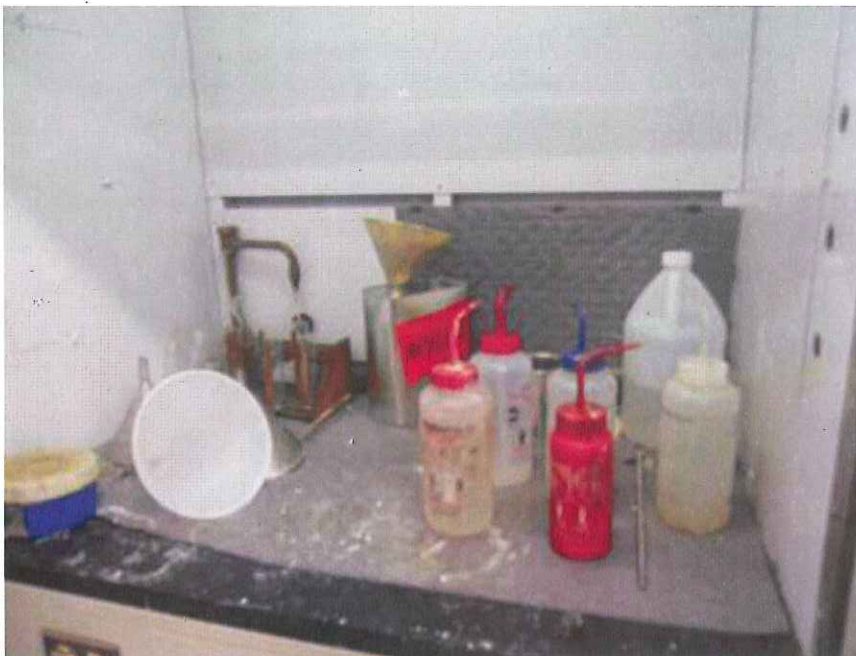
Laboratory. Waste containers located under a hood. The SAA container was not closed.

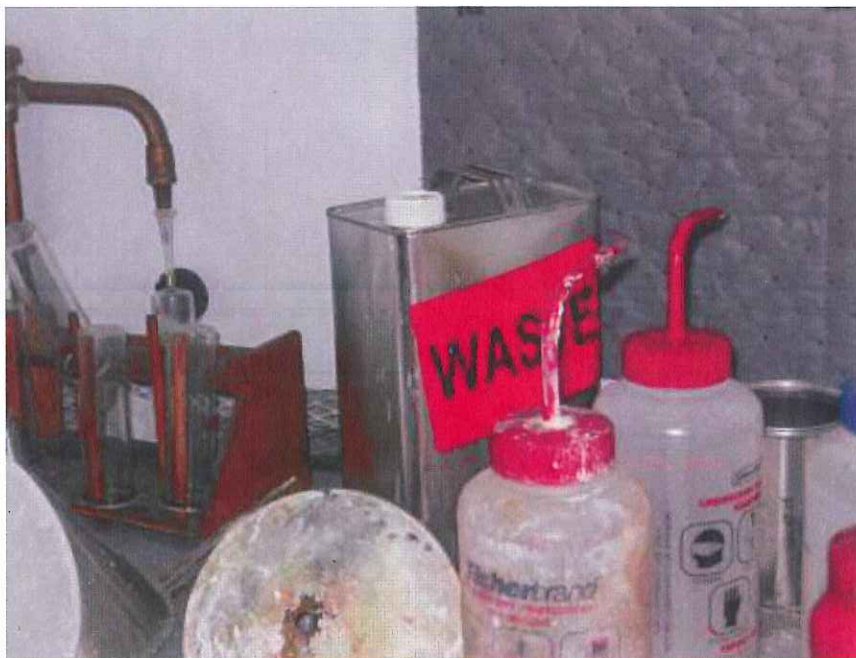
Disk Number 1
Photo Number 16
Photo Filename DSCN0871.JPG
Date/Time 7/23/2015
12:04:00 PM
Photographer Jamie Paulin

Laboratory. SAA container of hazardous waste. Emco put the cap back onto the container at the time of the inspection.

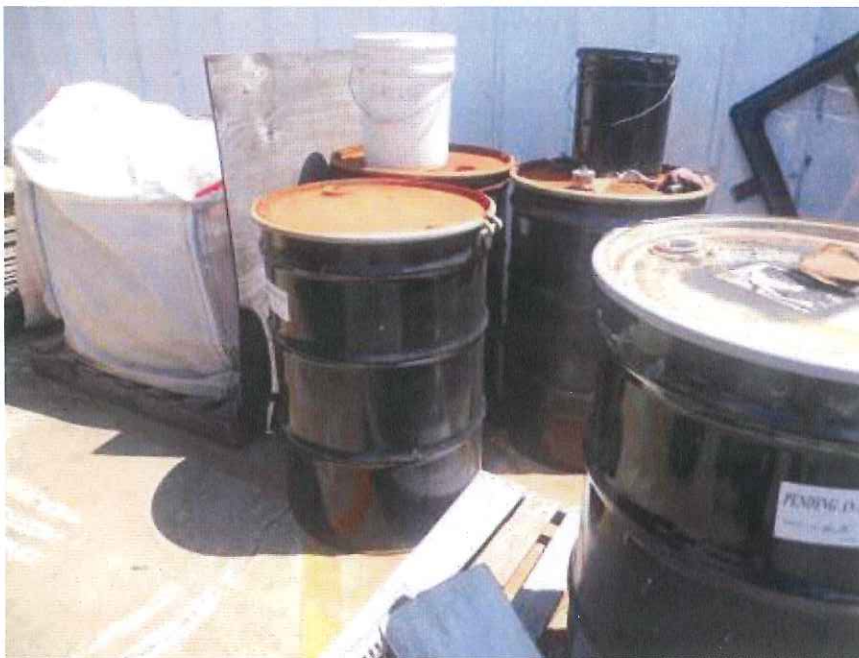
Waste Pad Storage Area. Pending waste was collected from "clean-out," and being stored in this location. Emco has sent out a sample for analysis to determine if it is hazardous waste.

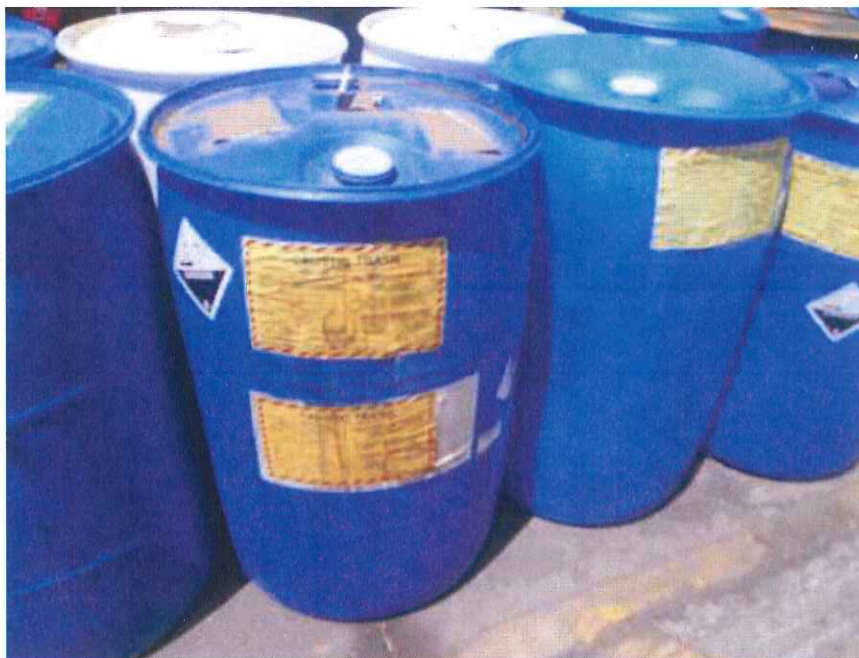
Disk Number 1
Photo Number 18
Photo Filename DSCN0873.JPG
Date/Time 7/23/2015
12:15:00 PM
Photographer Jamie Paulin

Waste Pad Storage Area. 55-gallon containers of hazardous waste storage. This container did not contain a date of accumulation.

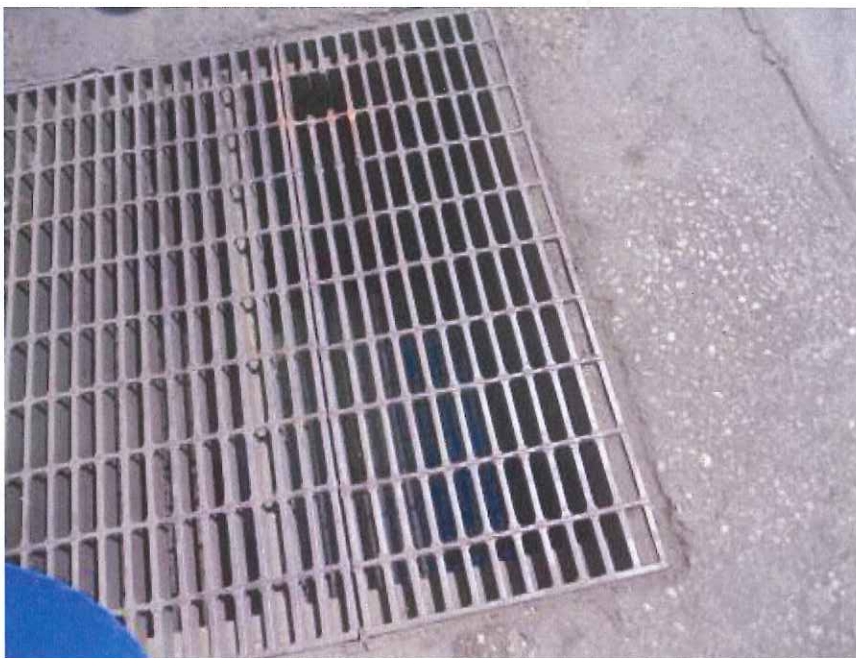
Pit located outside in the Waste Pad Storage Area. The pit collected rain water and was present in case of a spill. Periodically Emco collected the material in the pit for disposal.

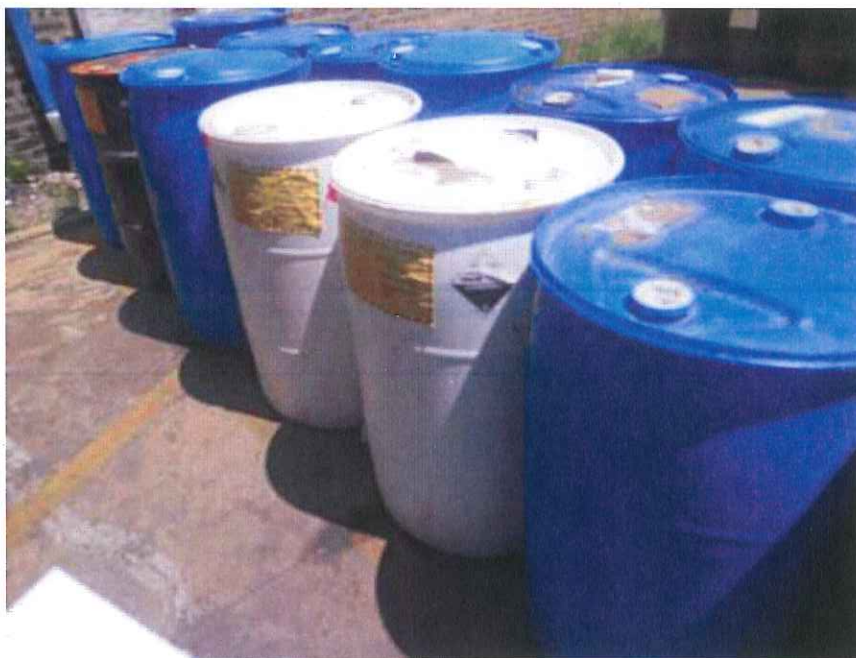
Disk Number 1
Photo Number 20
Photo Filename DSCN0875.JPG
Date/Time 7/23/2015
12:17:00 PM
Photographer Jamie Paulin

Waste Pad Storage Area. 55-gallon storage of hazardous waste. Two blue 55-gallon containers did not have any labeling; no date of accumulation and no words, "Hazardous Waste."

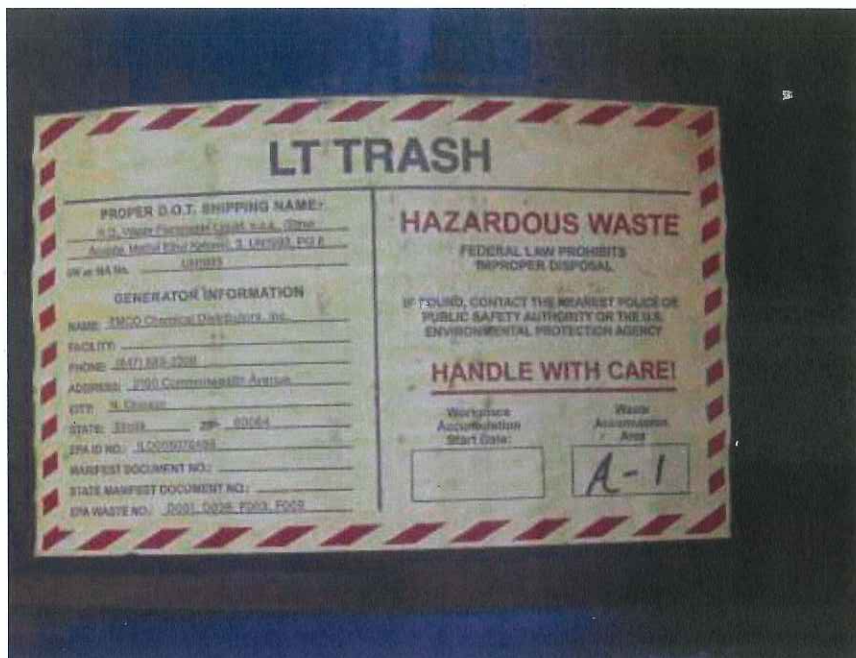
Waste Pad Storage Area. 55-gallon container of hazardous waste did not have a date of accumulation.

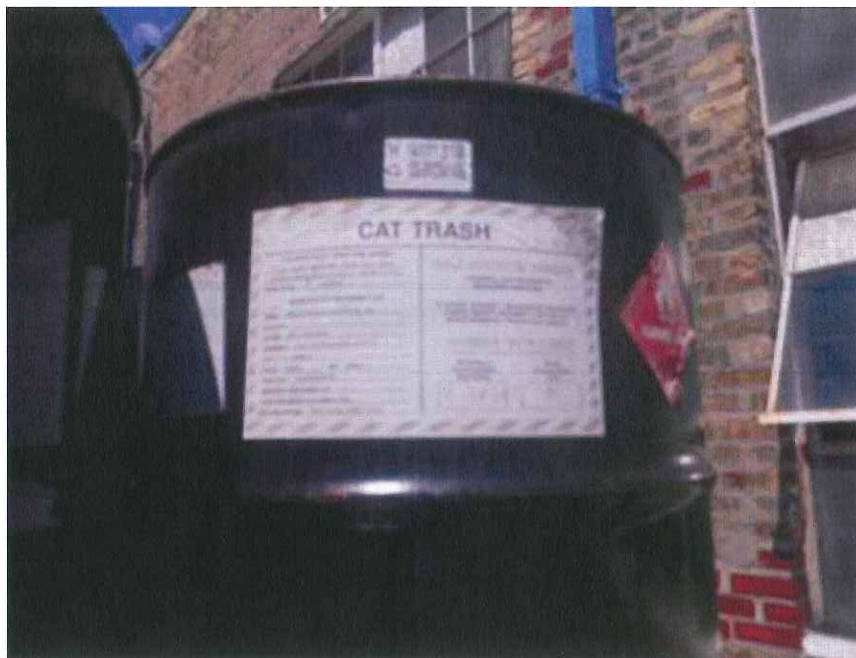
Disk Number 1
Photo Number 22
Photo Filename DSCN0877.JPG
Date/Time 7/23/2015
12:23:00 PM
Photographer Jamie Paulin

Waste Pad Storage Area. 55-gallon container of hazardous waste was labeled with a date of accumulation of 2/13/15. Mr. Ruszczak explained that Emco has no method of disposing of the hazardous waste.

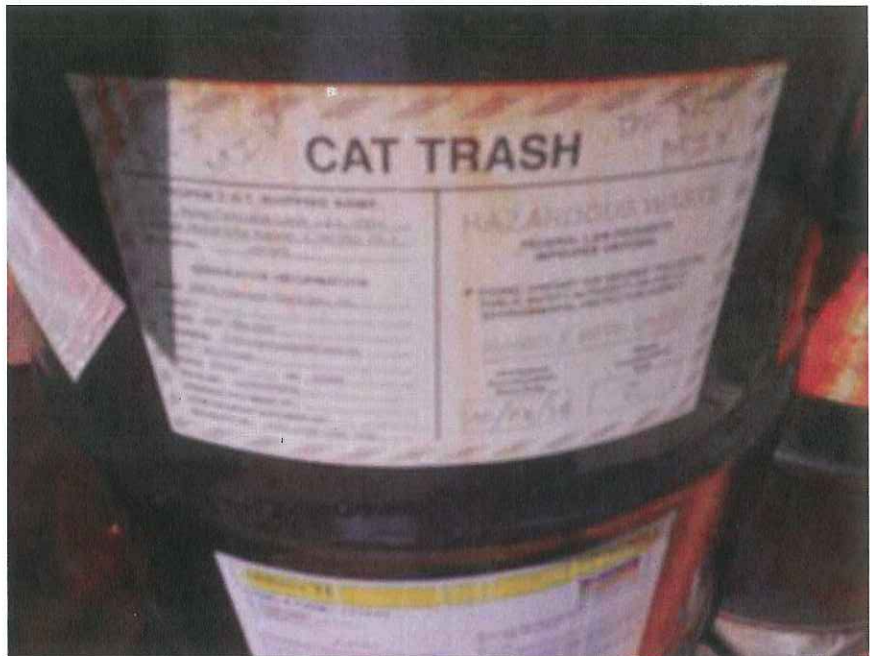
Waste Pad Storage Area. 55-gallon container of hazardous waste was labeled with a date of accumulation of 10/28/14. Mr. Ruszczak explained that Emco has no method of disposing of the hazardous waste.

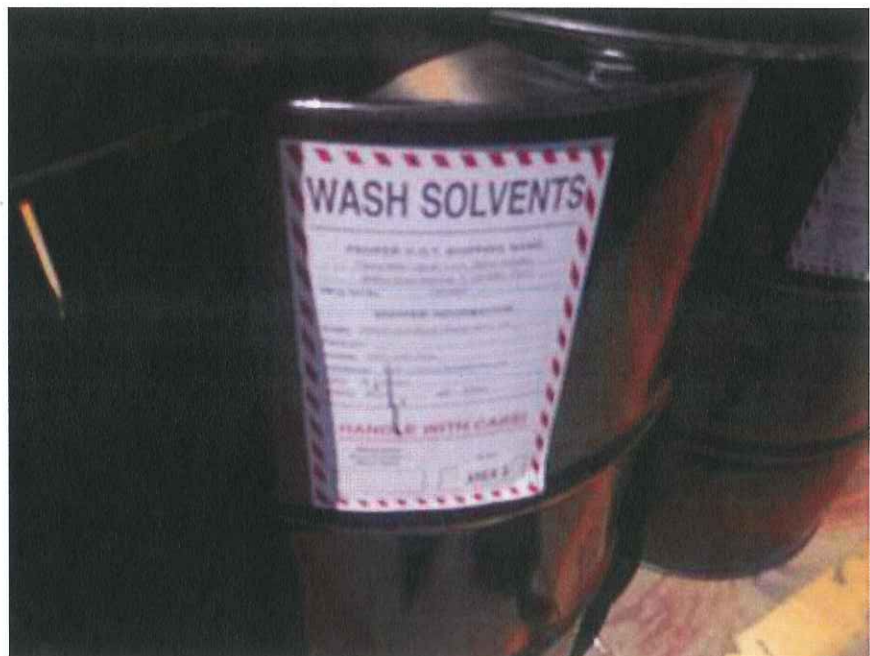
Disk Number 1
Photo Number 24
Photo Filename DSCN0879.JPG
Date/Time 7/23/2015
12:23:00 PM
Photographer Jamie Paulin

Waste Pad Storage Area. 55-gallon container of hazardous waste was not labeled with a date of accumulation or the words, "Hazardous Waste," located on the container.

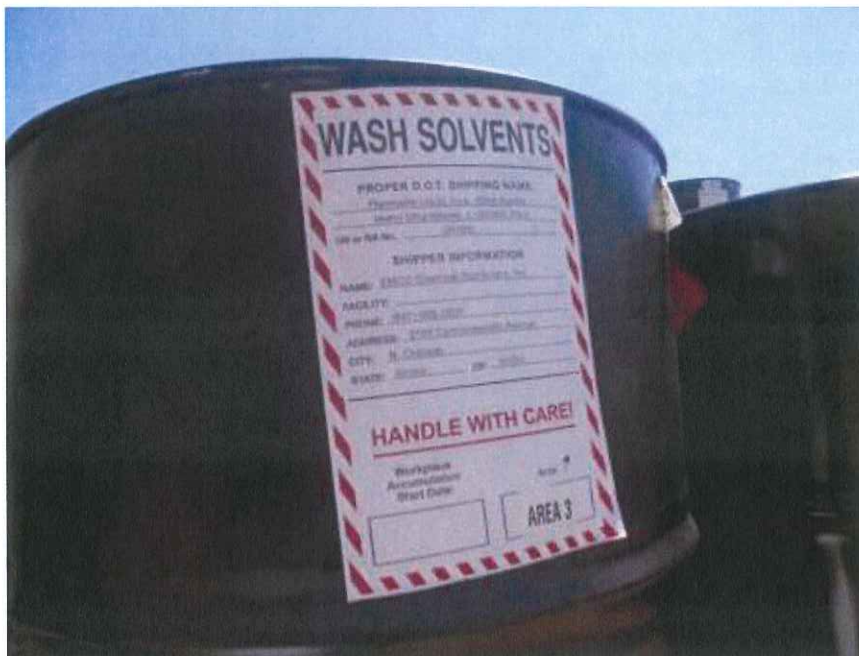
Waste Pad Storage Area. 55-gallon container of hazardous waste was not labeled with a date of accumulation or the words, "Hazardous Waste," located on the container.

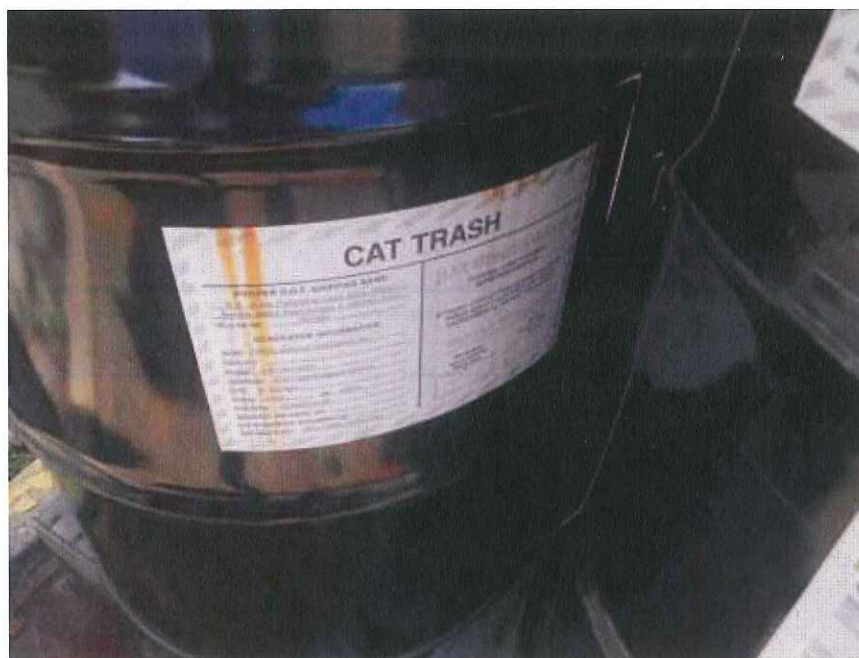
Disk Number 1
Photo Number 26
Photo Filename DSCN0881.JPG
Date/Time 7/23/2015
12:23:00 PM
Photographer Jamie Paulin

Waste Pad Storage Area. 55-gallon container of hazardous waste did not have a date of accumulation.

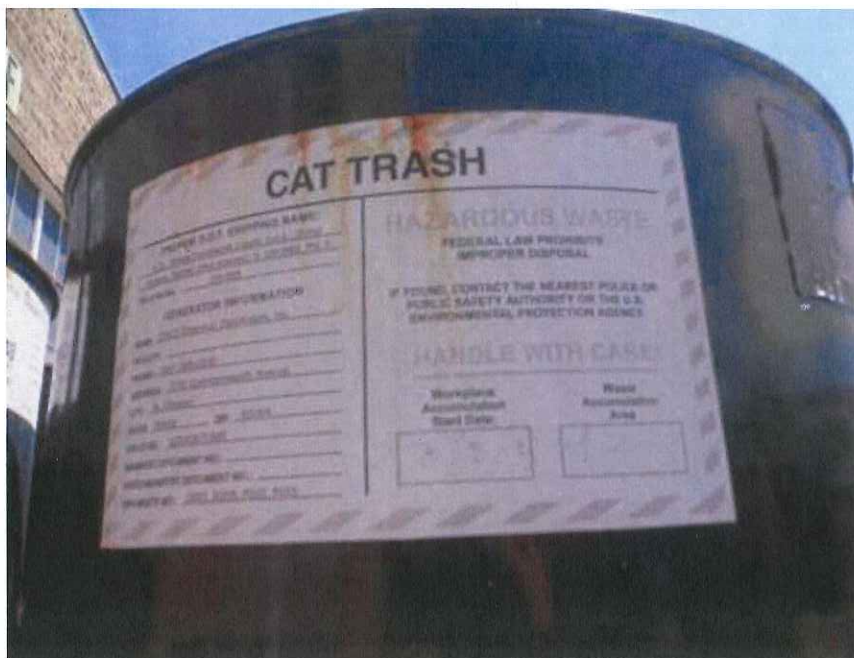
Waste Pad Storage Area. 55-gallon container of hazardous waste was labeled with a date of accumulation of 3/10/15. Mr. Ruszczak explained that Emco has no method of disposing of the hazardous waste.

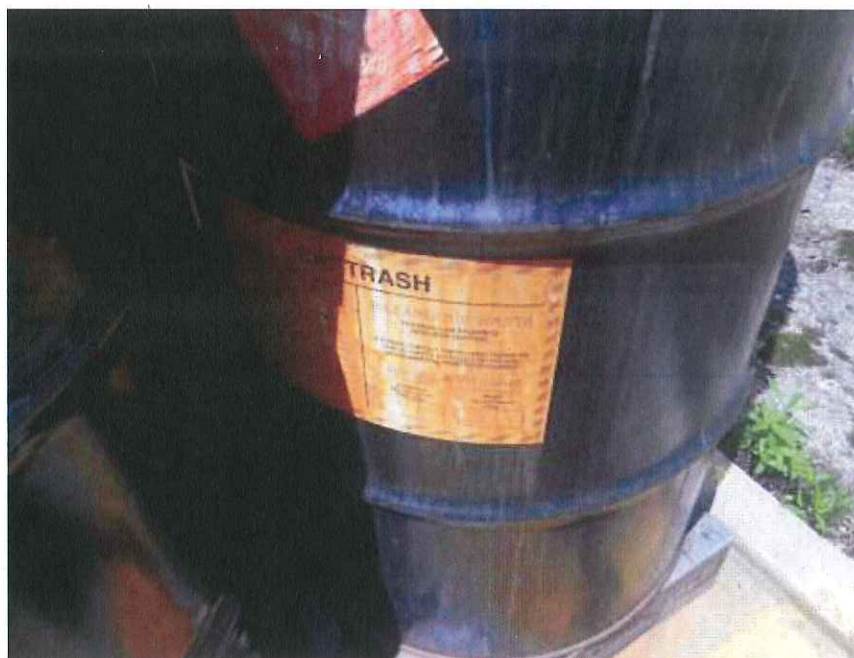
Disk Number 1
Photo Number 28
Photo Filename DSCN0883.JPG
Date/Time 7/23/2015
12:25:00 PM
Photographer Jamie Paulin

Waste Pad Storage Area. 55-gallon container of hazardous waste was labeled with a date of accumulation of 8/21/14. Mr. Ruszczak explained that Emco has no method of disposing of the hazardous waste.

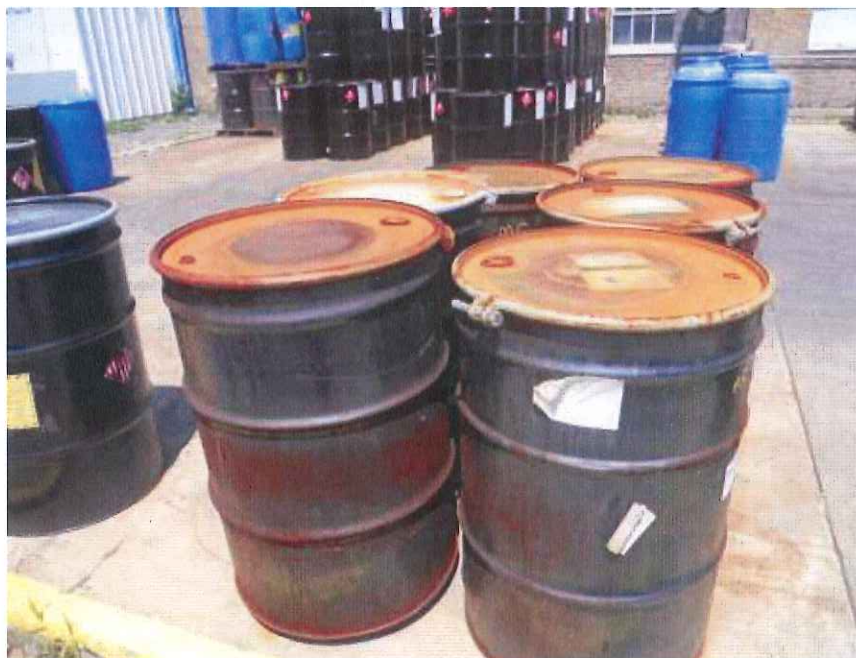
Disk Number 1
Photo Number 30
Photo Filename DSCN0885.JPG
Date/Time 7/23/2015
12:30:00 PM
Photographer Jamie Paulin

- Six 55-gallon containers were being stored in the area without a date of accumulation or the words, "Hazardous Waste." EMCO stated that these were pending analysis to determine if they were hazardous. (*See*, photograph 30)

Waste Pad Storage Area. Six 55-gallon containers were not labeled with a date of accumulation or words, "Hazardous Waste." Emco stated that they were pending analysis to determine if hazardous.

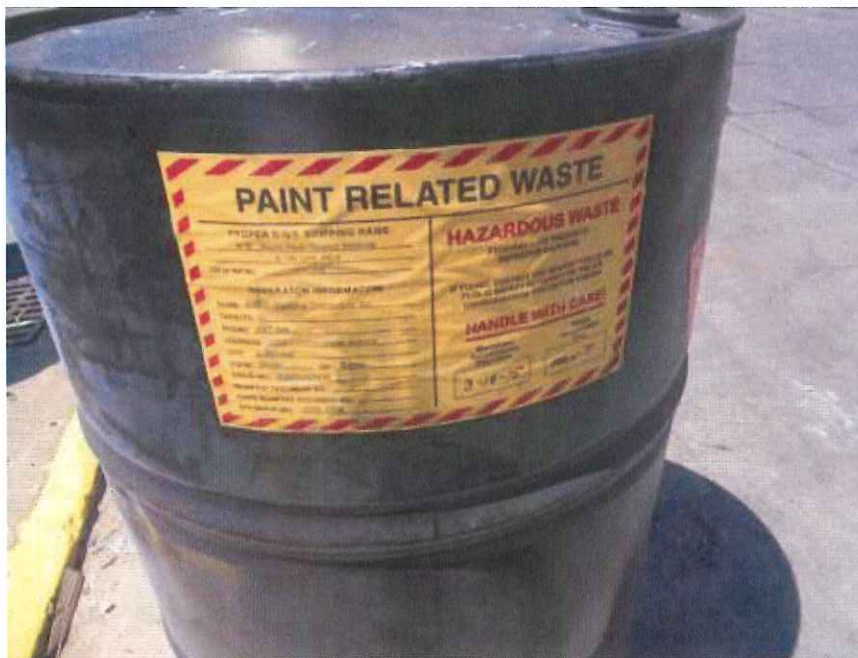
Waste Pad Storage Area. 55-gallon container of hazardous waste was labeled with a date of accumulation of 3/10/15, greater than the 90 day storage time allowed.

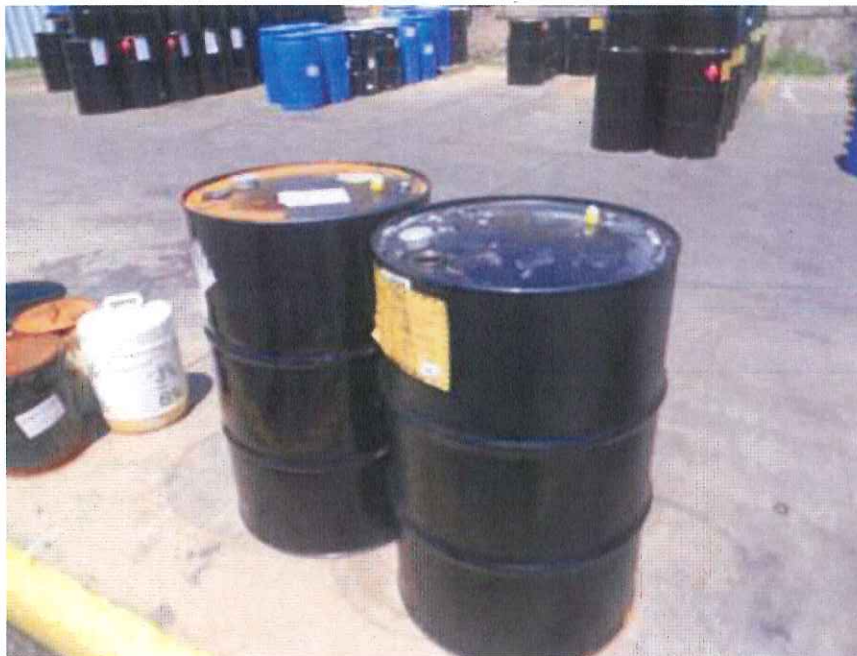
Disk Number 1
Photo Number 32
Photo Filename DSCN0887.JPG
Date/Time 7/23/2015
12:32:00 PM
Photographer Jamie Paulin

Waste Pad Storage Area. Two open 55-gallon containers of hazardous waste were being stored without dates of accumulation. Emco did put a date of accumulation on the containers and lids on at the time of the inspection.

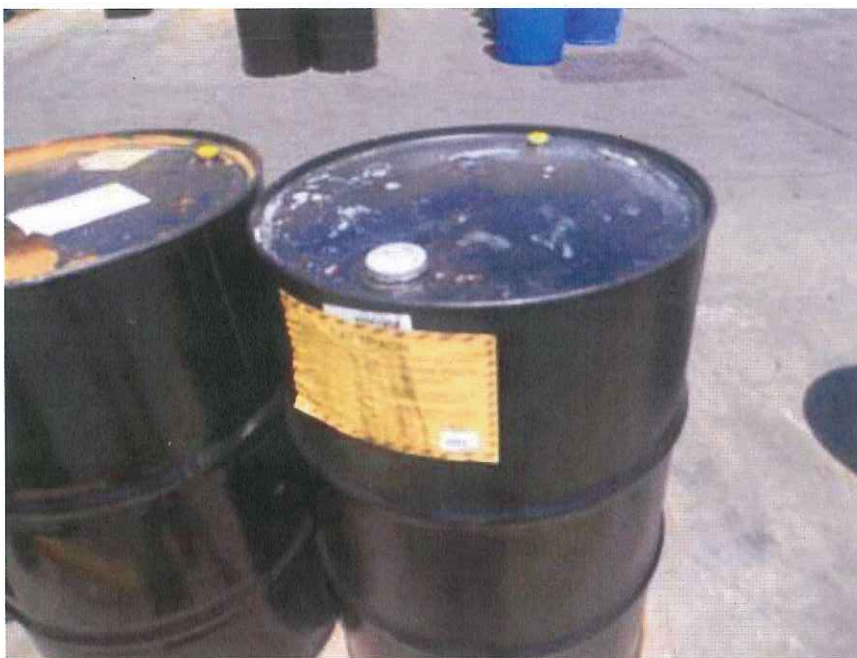
Waste Pad Storage Area. Two open 55-gallon containers of hazardous waste were being stored without dates of accumulation. Emco did put a date of accumulation on the containers and lids on at the time of the inspection.

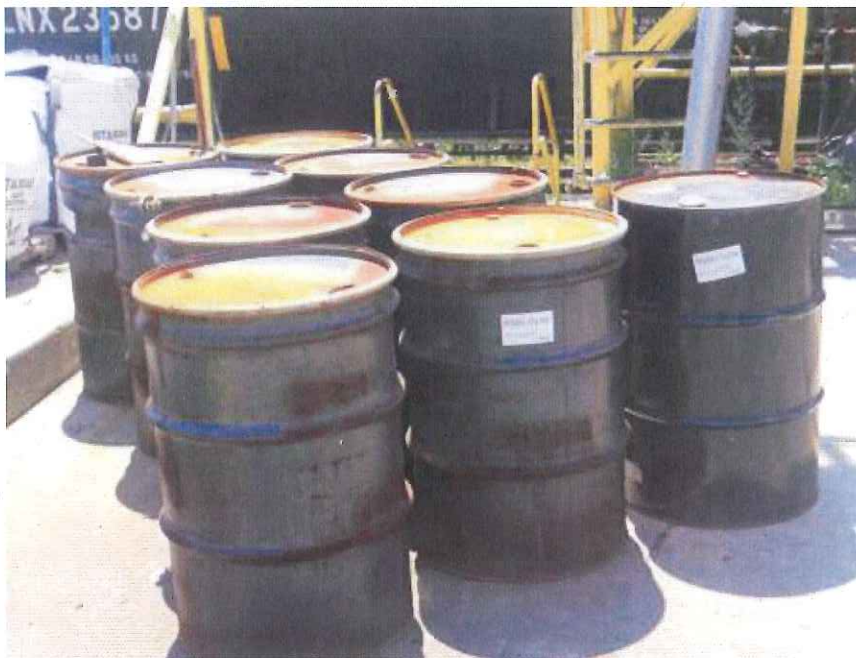
Waste Pad Storage Area. Nine 55-gallon containers of waste awaiting analysis for hazard determination.

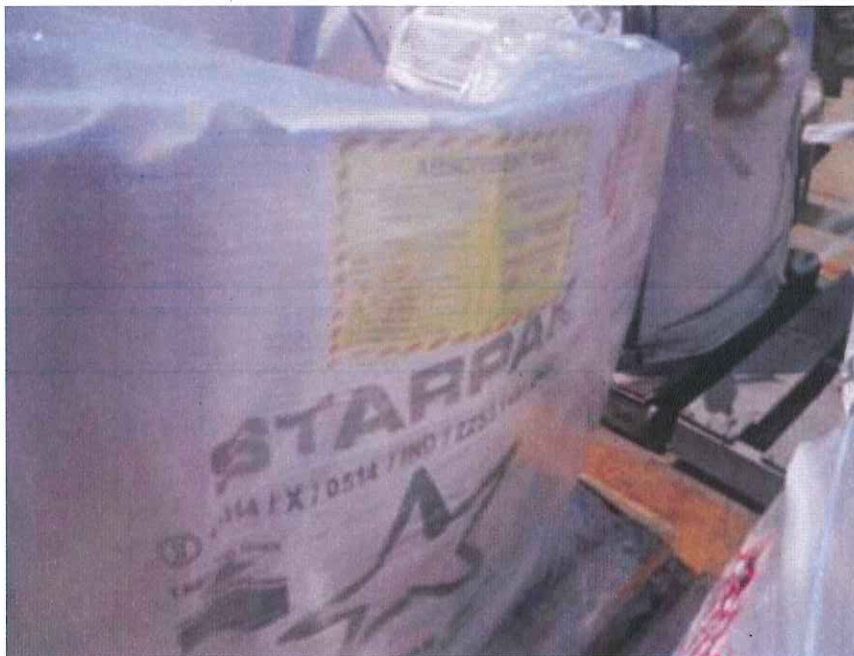
Disk Number 1
Photo Number 36
Photo Filename DSCN0891.JPG
Date/Time 7/23/2015
12:37:00 PM
Photographer Jamie Paulin

Waste Pad Storage Area. Totes of hazardous waste from the laboratory were being stored in this location on pallets. No date of accumulation was located on the tote.

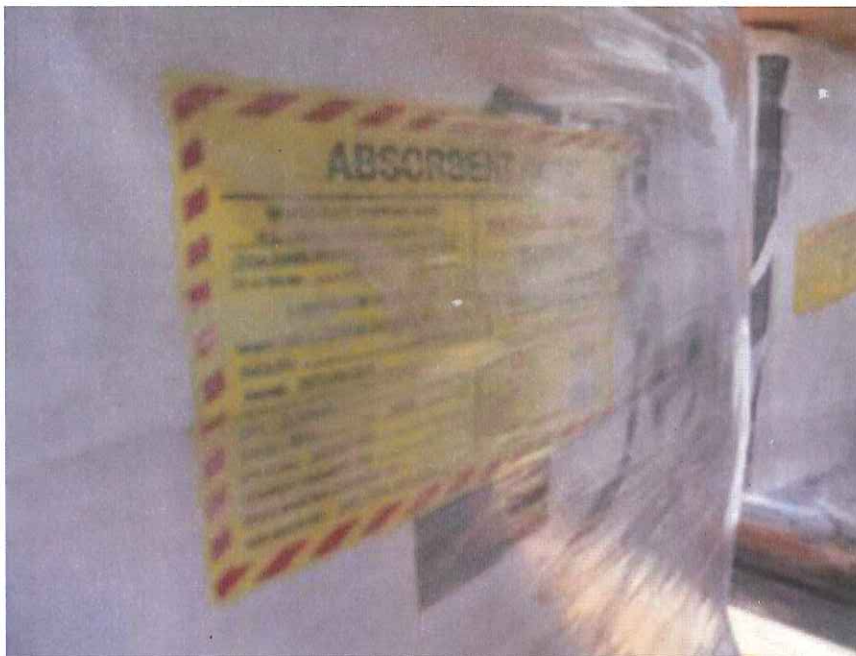
Waste Pad Storage Area. Totes of hazardous waste from the laboratory were being stored in this location on pallets. No date of accumulation was located on the tote.

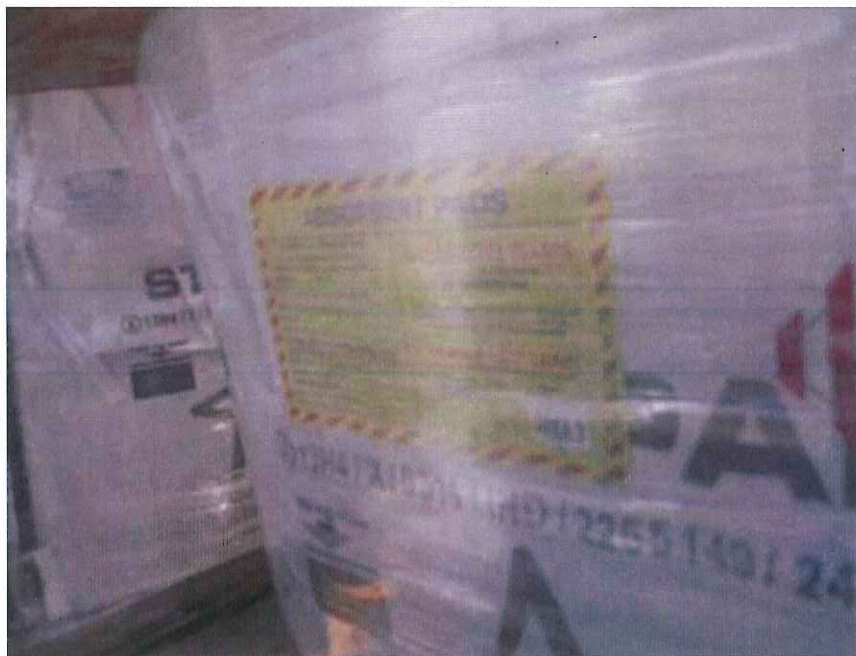
Disk Number 1
Photo Number 38
Photo Filename DSCN0893.JPG
Date/Time 7/23/2015
12:39:00 PM
Photographer Jamie Paulin

Waste Pad Storage Area. Totes of hazardous waste from the laboratory were being stored in this location on pallets. No date of accumulation was located on the tote.
